Manhole Inspection Summary

Manhole # S51S1_004MH

Location Address: **3101 Frankfurst Ave.**

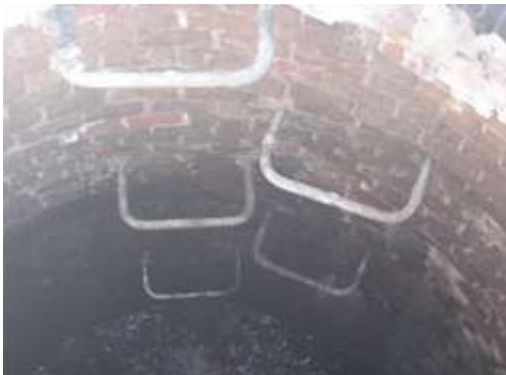
Steps Count: **5** Missing: **0** ☒ **Corroded**

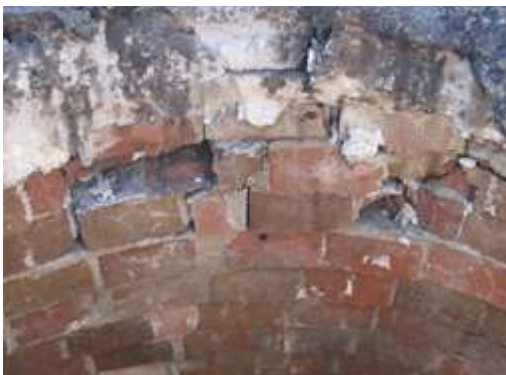
Defect 1

Condition: ☐ Sound ☒ **Cracked** ☐ Root Intrusion ☐ Loose Brick ☒ **Deteriorated**

Deteriorated corbel

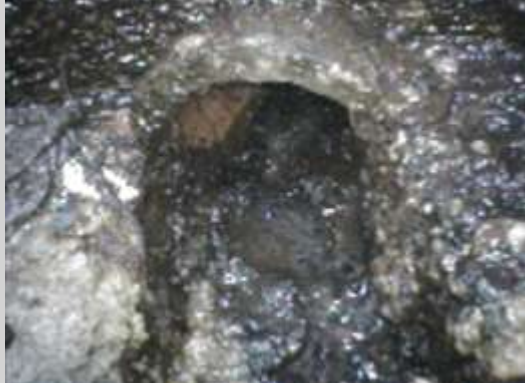
8 O'Clock Inflow

Deposits: ☐ None ☐ Mud ☐ Sludge ☒ **Debris** ☐ Grease

Silt Depth: **2** (in.) Deposits Extent: **Medium**
